The EVent Ventless Grill has an aluminum air flow tube that facilitates the air flow within the grill. If this tube becomes clogged with grease or food debris, the air flow may be blocked and can cause the fan to shutdown. ***Evo recommends that the air flow tube be checked and cleaned monthly.***

Cleaning Steps:

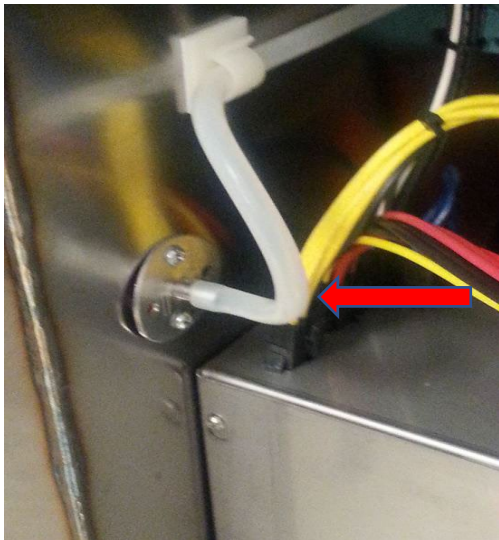
#1 Air Flow Tube w/ silicone tubing attached. Pull off silicone tubing to begin.

1. Locate silicone tubing attached to the air flow tube towards the top of the back wall. *Pipe cleaners may be located inside of side panel next to air flow tube. (newer units)*
2. Pull silicone tube from the metal spoke on the air flow tube.
3. Insert a narrow cleaning tool (pipe cleaner is recommended) into the metal tube.
 - a. The air flow tube exits on the Chef Side of the EVent in the grease filter compartment.
 - b. Unlock the grease filter compartment, remove the baffle grease filter, and pull the pipe cleaner through from the grease filter compartment.
4. Process should be repeated until all grease and debris has been removed.

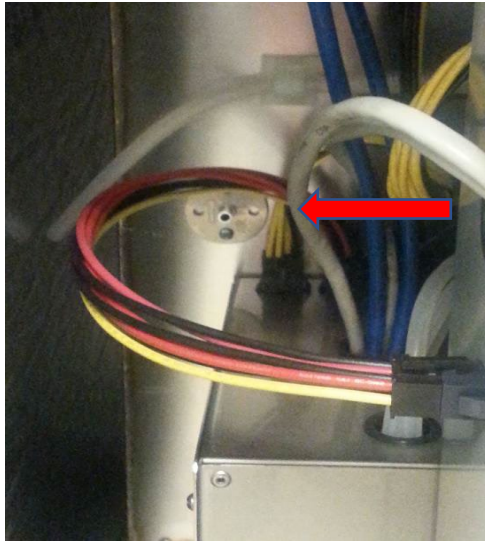
#2 Silicone tubing removed. Air Flow Tube ready to clean

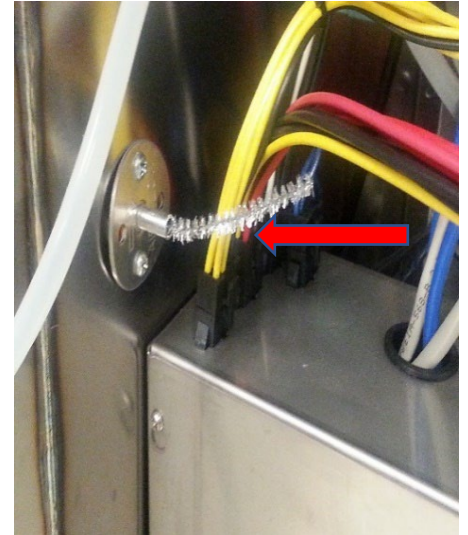
#3 Pipe Cleaner inserted into tube opening

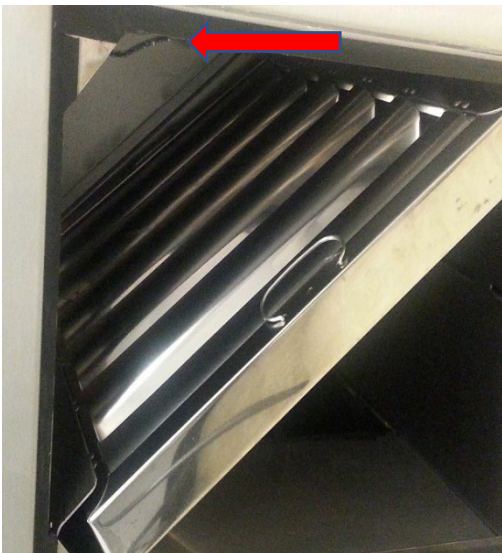
#4 Pipe Cleaner exit on top of wall in grease filter box. Remove grease filter and pull out the pipe cleaner. Repeat if needed to remove all debris.

IMPORTANT – PIPE CLEANER SHOULD BE PULLED OUT FROM THE GREASE FILTER COMPARTMENT. DO NOT PULL OUT FROM THE ORIGIN POINT AS THIS WILL TRAP GREASE IN THE TUBE AND CONTINUE TO BLOCK AIR FLOW
